Factors influencing deoxygenation following an unintended whole of water body herbicide treatment of aquatic weed cabomba in a natural wetland in the Blue Mountains, NSW, Australia.

Christina Day¹, Ian A. Wright², Amy St Lawrence¹, Robert Setter¹, Geoffrey Smith¹

Environment Branch, Blue Mountains City Council, Locked Bag 1005, Katoomba, NSW, 2780. <u>cday@bmcc.nsw.qov.au</u>
 School of Science and Health, University of Western Sydney, Locked Bag 1797, Penrith, NSW 2751. <u>i.wright@uws.edu.au</u>.

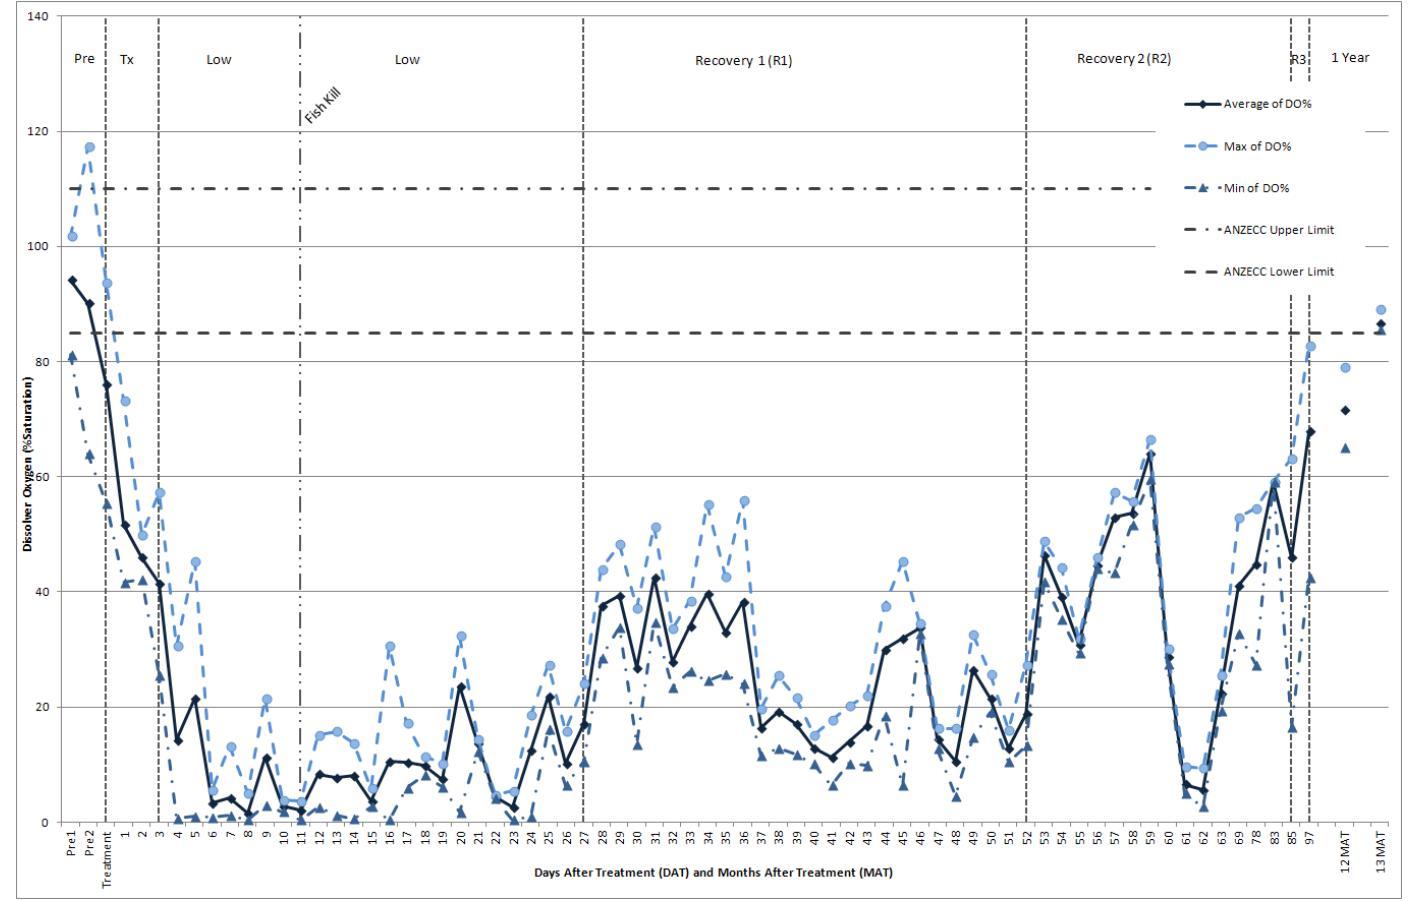
Diurnal records of dissolved oxygen concentration showed periods where levels were close to zero for large portions of the day. On 15 December 2012 (11 DAT) the data logger recorded a period between 11 am to midnight of 0.4% DO saturation (0.03-0.04 mg/L). At some time during this period a fish kill of approximately 50 stocked Australian bass occurred. The maximum water temperature recorded during this period was 23.67°C. Australian Bass had not been recorded in the lagoon during pre-treatment surveys (AMBS 2012) and stocking of this fish was thought to have ended decades earlier due to poor water quality in the lagoon making it unsuitable for recreational fishing.

Figure 2: Average, Maximum and Minimum Dissolved Oxygen (% Saturation) recorded from Glenbrook Lagoon: 9-11am from 26 November 2012 to 15 January 2014. ANZECC (2000) upper and lower values indicated (85-110%). Vertical dashed lines indicate Categories: Pre-treatment (Pre); Treatment (Tx); Low DO (Low); Recovery phase 1 (R1); Recovery phase 2 (R2); Recovery phase 3 (R3); 1 Year After (1 Year). Vertical -..-- line represents fish kill event.

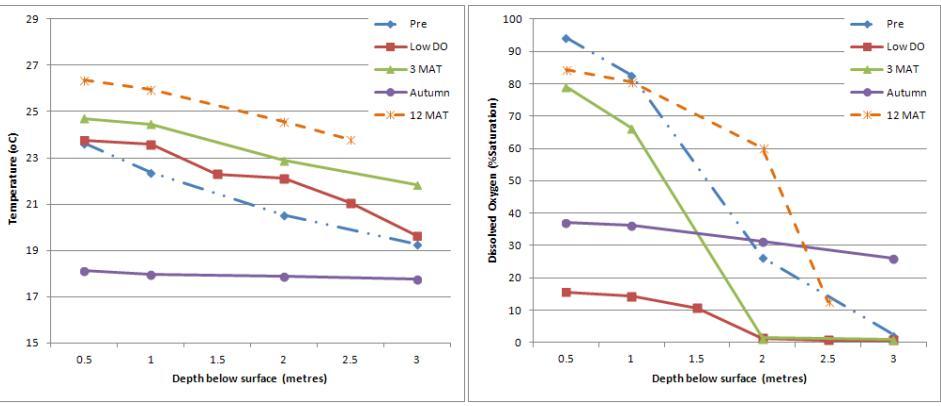
Figure 3: Left: Water temperature (° C) profiles and Right: dissolved oxygen (% Sat) profiles during 5 time periods (Pre; Low DO; Recovery phase 3 (3 MAT); autumn 2013; and 12 months after treatment).

DO observed below the thermocline suggest a significant volume of the lagoon was anoxic prior to the sudden addition of large quantities of dead plant material and this will have contributed to the severity of deoxygenation that occurred.

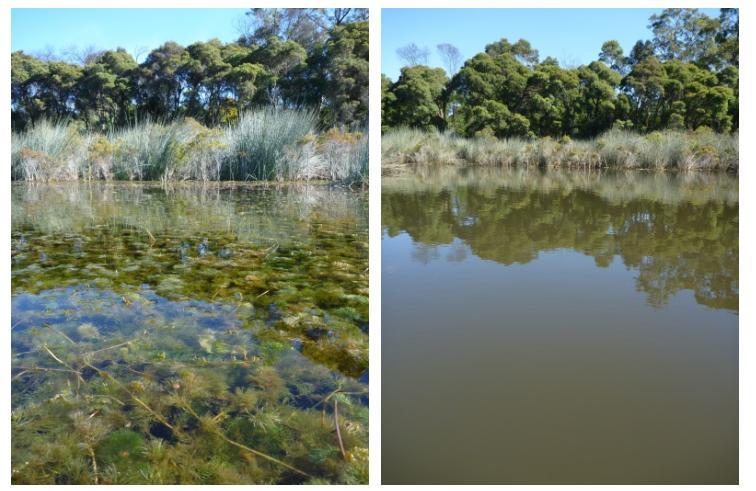
Photo plates: Glenbrook Lagoon showing: cabomba pretreatment (left) and post-treatment (middle); water lily pretreatment (top right) and post-treatment (bottom right).
