Factors influencing deoxygenation following an unintended whole of water body herbicide treatment of aquatic weed cabomba in a natural wetland in the Blue Mountains, NSW, Australia.

Christina Day¹, Ian A. Wright², Amy St Lawrence¹, Robert Setter¹, Geoffrey Smith¹

Environment Branch, Blue Mountains City Council, Locked Bag 1005, Katoomba, NSW, 2780. <u>cday@bmcc.nsw.qov.au</u>
 School of Science and Health, University of Western Sydney, Locked Bag 1797, Penrith, NSW 2751. <u>i.wright@uws.edu.au</u>.

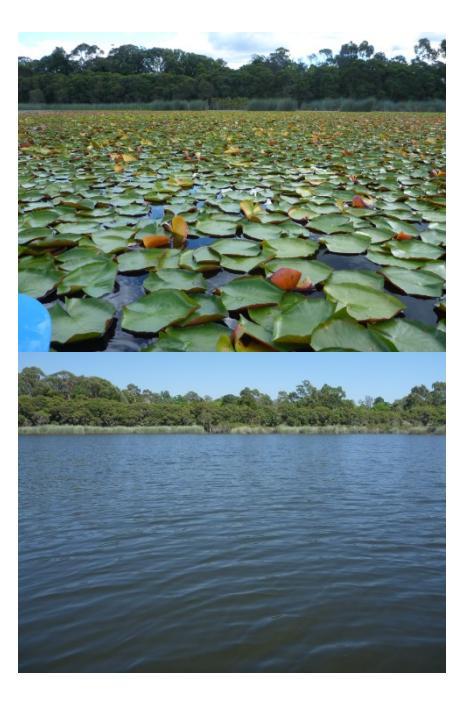
Following application of Shark to 50% of Glenbrook Lagoon, lateral herbicide drift resulted in complete dieback of cabomba and the remaining healthy water lily across the entire lagoon (photos in appendix). This was an unexpected outcome as the influence of stratification was not appreciated at the time and plans were in place for a follow up treatment 3 months later to treat the other half. The greater than expected dieback resulted in a more severe decline in oxygen levels than anticipated and was the likely cause of a fish kill. Rapidly declining dissolved oxygen (DO) concentrations were recorded at 10 am (+/- 1 hour) in the first four days and a minimum of 0.7% (0.07 mg/L) was recorded 4 DAT (days after treatment). This was followed by *c*. 23 days of extremely low DO (mean: 10.31%; 0.88 mg/L; minimum: 0.4%; 0.03 mg/L) before beginning to show signs of a slow recovery, reaching a maximum of 82.8% (6.4 mg/L) after more than 3 months. Pre-treatment DO levels average 92.35% (7.93 mg/L) with a range of 64 - 117.3% (5.48 - 10.05 mg/L) (Figure 2 and Table 2). A further drop in DO was recorded in April 2013 (5 MAT (months after treatment), believed to be related to autumn water column turnover (Figure 3). 13 MAT recorded DO levels were within ANZECC (2000) guidelines for ecosystem health.

Photo plates: Glenbrook Lagoon showing: cabomba pretreatment (left) and post-treatment (middle); water lily pretreatment (top right) and post-treatment (bottom right).
